ENERGY AUDIT REPORT

for 6 Milvan Drive, North York, Ontario

ABS File No. G-EA-10.02

Date: January 10th, 2011

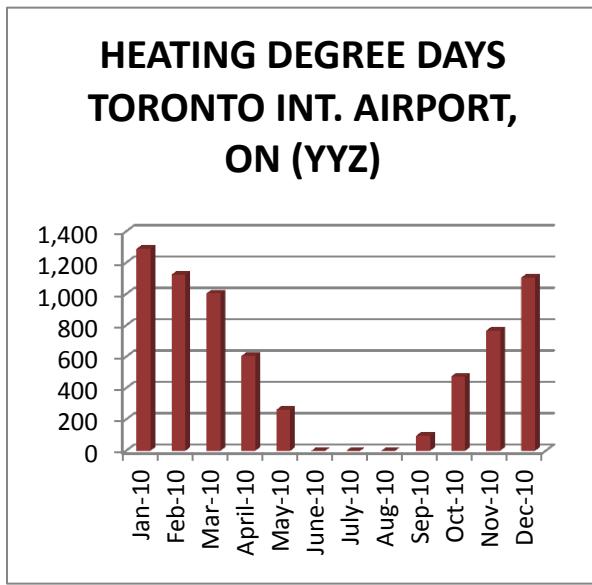
CHART-1

Total Heating Degree Days – 6728, (75%)

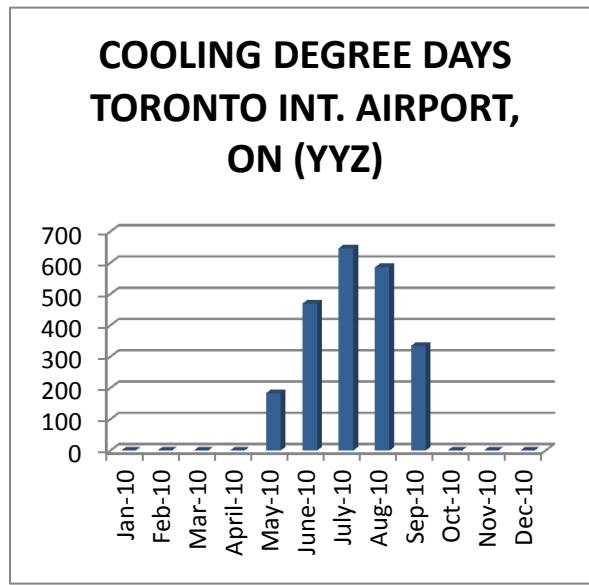
CHART-2

Total Cooling Degree Days – 2222, (25%)

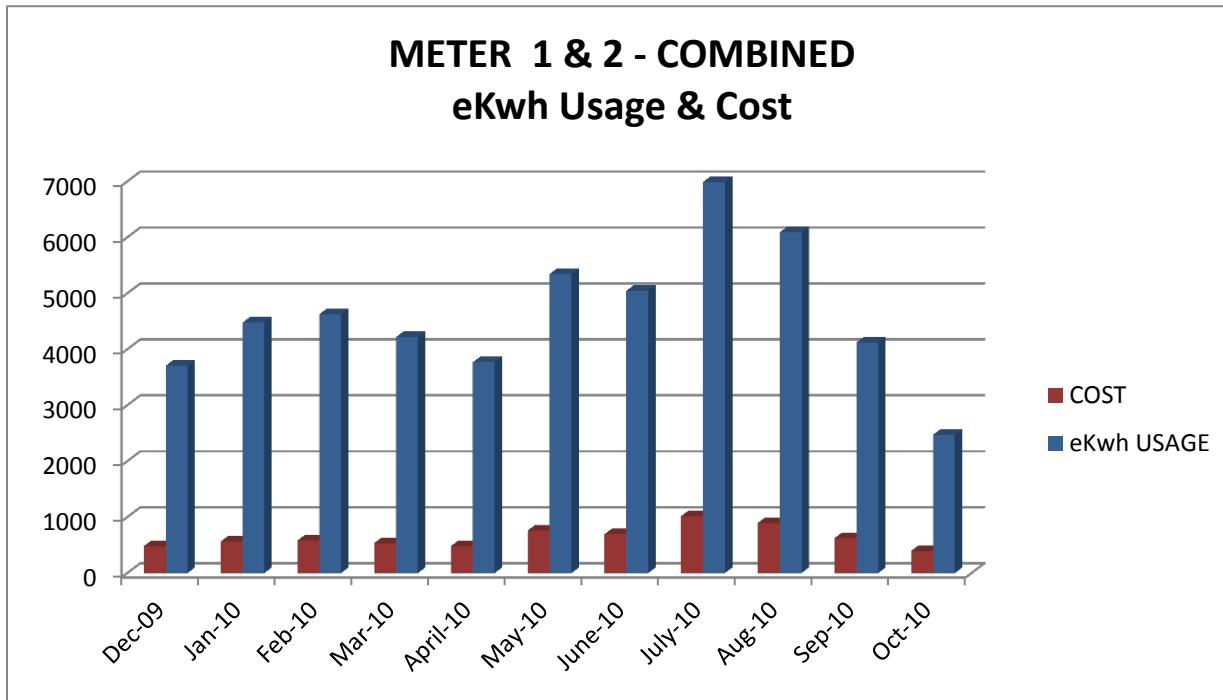
CHART-5: Represent electrical consumption of combine building electrical services: 200-amps, 120/240-volt, single-phase service and 200-amps, 600-volt, three-phase electrical service.

The electrical consumption profile in Chart-5 above, reflect a non-consistent use of electrical energy in the building. The consumption stays near peak levels in the months of May, June, July and August which represent the cooling months. October consumption in particular seems to be low. Through autumn and most of the winter there is no significant drop in consumption that would normally be expected from reduced cooling loads. However, due to energy losses and based on this analysis the building energy consumptions can be reduce by implementing the measures as recommend in this report.

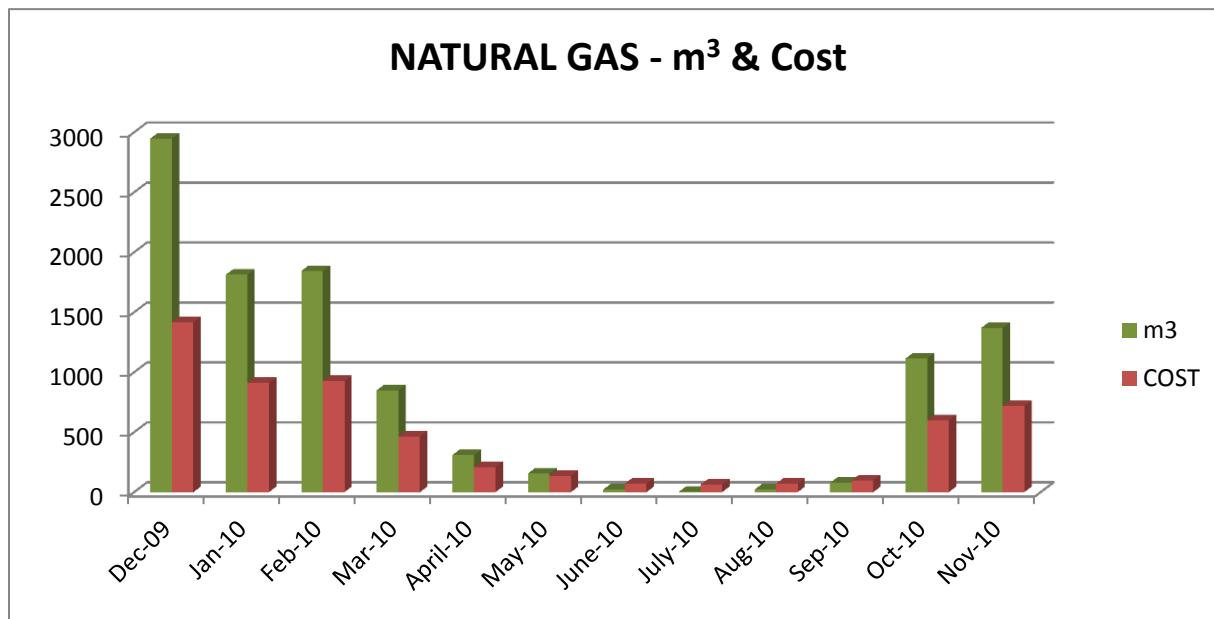
CHART-6

Natural gas consumption of the building as indicated in Chart-6 reflects that the gas consumption reduces significantly during the summer months. The only gas used in the summer month is to heat the domestic hot water. The usage trend seems obvious but surprisingly high in the December due to high infiltration and energy losses from windows, doors etc, throughout the building. Our investigation reveals that as a result of poor Wall/Roof insulation (R-6), air leaking doors and windows makes the building vulnerable to energy losses.

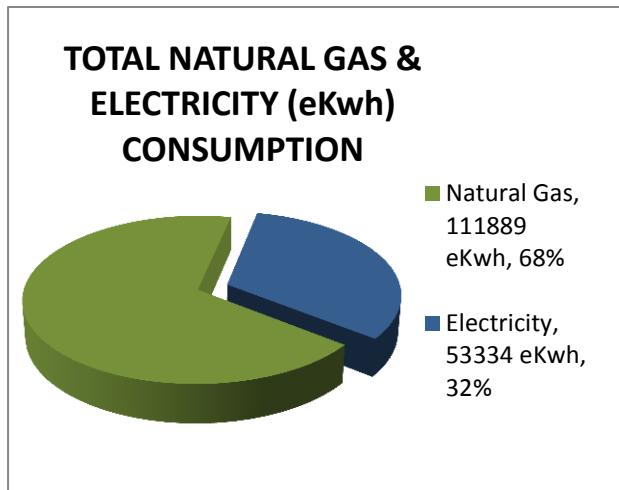
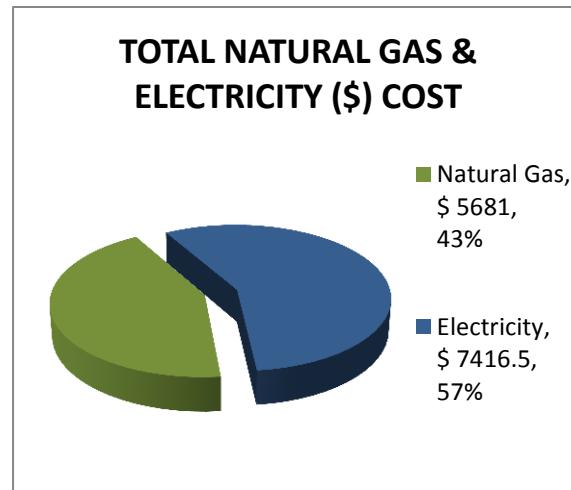
Chart-7 and Chart-8 represents total natural gas and electricity consumptions in similar eKwh units and total cost in Dollars. Surprisingly the total natural gas usage in eKwh units is extremely higher than electricity consumption within the building. Chart-7 reveals that the natural gas usage is approximately 111889 eKwh (350GJ) which is 68% and electricity usage is approximately 53334 eKwh (192GJ) which is 32% of the entire energy consumption. This results due to heating degree days and high infiltration and energy losses from windows, doors etc, throughout the building. Our investigation reveals that as a result of poor Wall/Roof insulation (R-6), air leaking doors and windows makes the building vulnerable to energy losses.

Although total consumption of natural gas energy is higher to electrical energy on annual basis, the electricity unit cost is much higher than natural gas in equivalent (ekWh) unit for the entire baseline period. Chart-8 reflects that the overall natural gas usage cost is \$5681 which is 43% and electricity usage cost is \$7416.5 which is 57% for the base case.

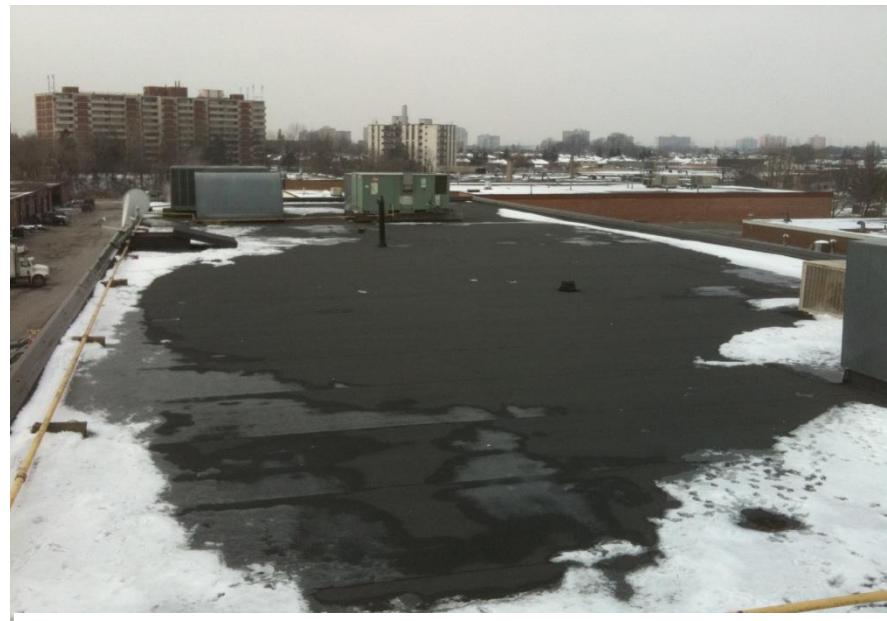
**Photo #2: Building Roof**

Building structure consist of concrete block foundations to support concrete block and brick veneer exterior walls. The steel roof deck and concrete floors are supported by open web steel joists which are supported by masonry bearing walls and exterior walls. Roof has been upgraded in late 2009. (Refer to Photo 2 in Appendix "B").

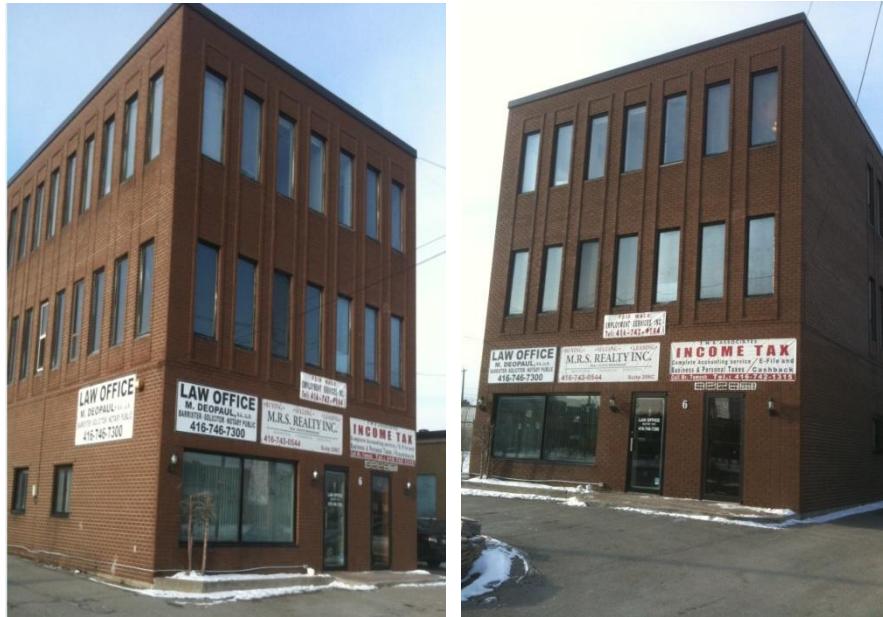
**Photo #3: Building Envelop**

Exterior building envelope consist of two-thirds walls (clad with brick veneer) with expanded polystyrene foam insulation (R-6) and one-third glazing unit which are aluminum framed, double glazed unit without any external shading devices. Some of the windows are operable type with horizontal sliders and these windows are leaking provide a greater means of air infiltration.

We recommend to replace the entire building windows with more efficient and air tight windows with improved thermal characteristics such overall heat transfer coefficient shall be 0.3 (Btu/h/ft²/F) and shading coefficient of 0.3.

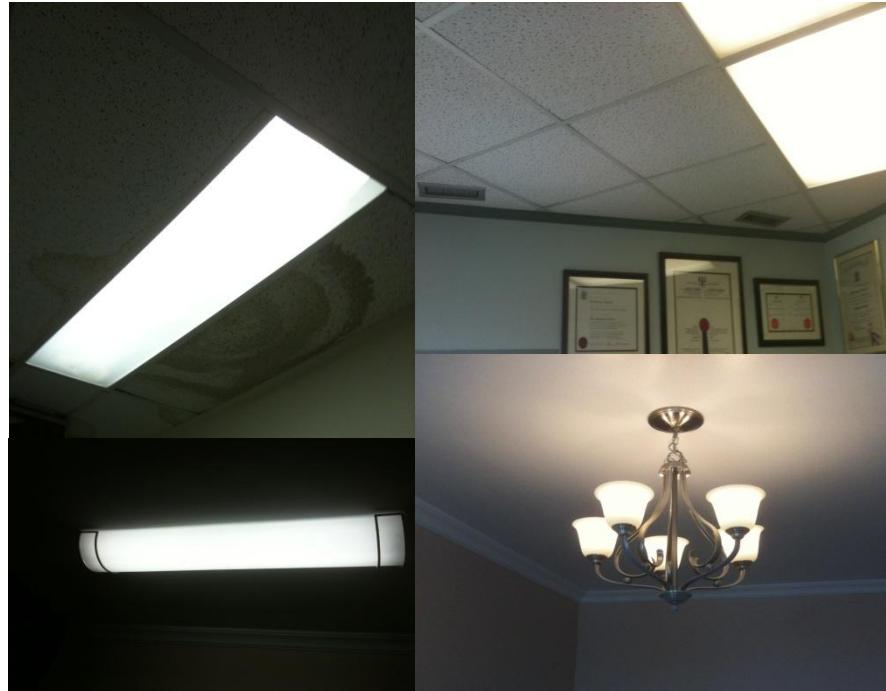
**Photo #5: Building Interior Lighting Fixtures**

Building Electrical system consists of two separate hydro meters, one is for 200-amps, 120/240-volt, single-phase service and second is for 200-amps, 600-volt, three-phase electrical service. In general, building has Fluorescent T12 lighting with 4 lamps each of 34 watts and 2 ballasts each of 40 watts in entire office suites, Fluorescent T12 with 2 lamps each of 34 watts & 1 ballast of 40 watts in Corridors & stairwells. Chandelier was found in 3rd floor East stairwell with five (5) Incandescent bulbs. Shipping area lighting consist of 4 Fluorescent T12 lighting fixture with 8 feet long 2 lamps each of 96 watts and 1 ballasts of 150 watts & adjacent office consist of one Fluorescent T12 with 2 lamps each of 34 watts and 1 ballast of 40 watts. The building is provided with exit lighting system consisting of EXIT signs with incandescent 50W bulbs. Exterior & Washroom lightings are surface mounted fixtures with one (1) Incandescent bulb. Front exterior light were on during site visit. (Refer to Photo 5 in Appendix "B" and List in Appendix "C").

2.2.4 Interior & Exterior Lighting: In general, building has Fluorescent T12 lighting with 4 lamps each of 34 watts and 2 ballasts each of 40 watts in entire office suites, Fluorescent T12 with 2 lamps each of 34 watts & 1 ballast of 40 watts in Corridors & stairwells. Chandelier was found in 3rd floor East stairwell with five (5) Incandescent bulbs.

Interior and Exterior Building Lighting: We recommend a number of lighting measures to replace the remaining aging and less efficient florescent T12 lighting lamps with T-5, reduce lighting levels in some areas as permitted by code and reduce run hours as much as possible. Replace existing incandescent exit signs with LED signs.

- Upgrading older lighting technology represents the greatest energy savings opportunity in lighting. We recommend replacing the Offices lighting with fluorescent T-5 of 21 watts with electronic ballast.
- Outdoor lighting consists of 8 fixtures and we assume it is Incandescent bulb to be replaced with compact fluorescent type lighting.
- Replace the building Stairwells lighting with fluorescent T-5 of 21 watts with electronic ballast.
- Replace existing incandescent exit signs of 50watts with LED signs of 15 watts.
- Replace the building Stairwells lighting with fluorescent T-5 of 21 watts with electronic ballast.

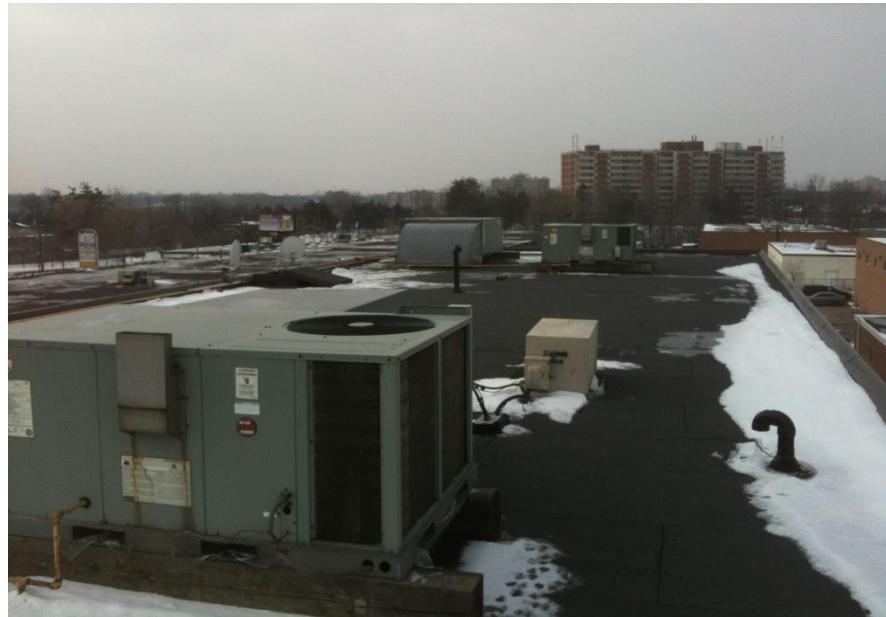
**Photo #6: 3 Building Heating & Cooling Units at Roof**

Building Heating and Cooling systems consist of three natural gas fired with air cooled DX electrical cooling rooftop units for second and third floors and for first floor there is one floor mounted natural gas fired furnace with duct mounted DX cooling coils with outdoor condensing unit. One condenser unit was found at roof. (Refer to Photo 6 in Appendix "B").

2.1.1 Heating, Natural ventilation and Air Conditioning (HVAC): Building Heating and Cooling systems consist of three natural gas fired with air cooled DX-R22 based electrical cooling, rooftop units of capacities 5 tons each for third floor offices suites and one 10 ton unit for second floor offices suites. For entire first floor there is one a floor mounted natural gas fired furnace with duct mounted DX cooling coils of 3 tons in capacity with outdoor condensing unit serving front office and west shipping area. One condenser unit was found at roof. East stairwell is provided with air system.

Heating, Ventilation and Air-Conditioning (HVAC): The main opportunities for energy conservation involve the replacement of original and aging three (3) constant volume rooftop units installed in 1998, with more efficient and more appropriately sized constant volume rooftop units with high efficiency motors, economizer and energy recovery system for fresh air.

We are recommending to replace these units with more energy efficient constant volume unit with gas fired two stage 80% efficient heating burner, Cooling seasonal COP of 5.0, R410A refrigerant, Free cooling, economizer, 75% effectiveness Energy Recovery system for Fresh Air, 2" internal insulation and programmable thermostats. We recommend to insulation and provide Variable air boxes or VAV diffusers in an existing ductwork system to achieve the seasonal performance of 5.0 and better temperature control of the building. Rebalance the entire HVAC System.

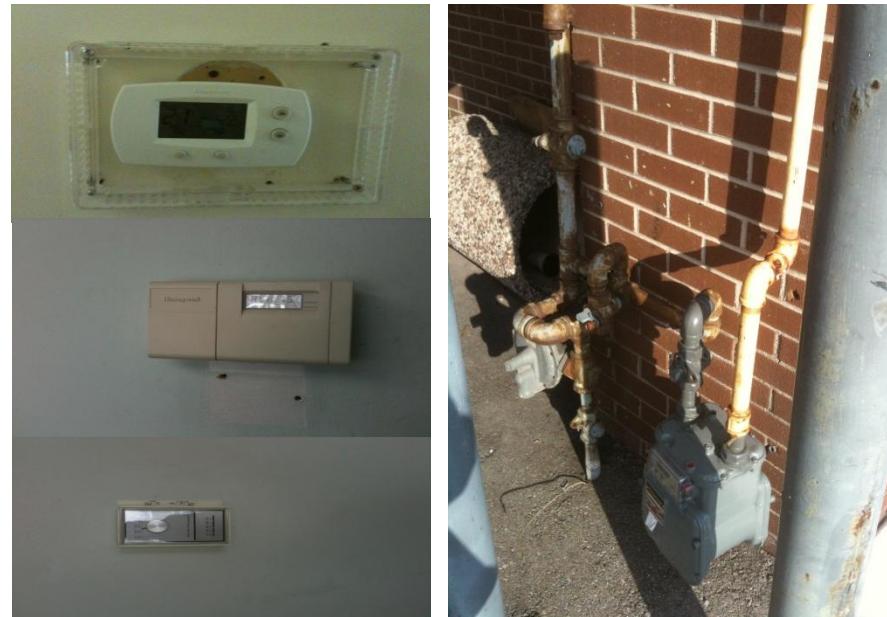
**Photo #7: Building Thermostats & Gas Meter.**

Five thermostats were found in entire building to control air temperature, two are located at third floor office suites one for each five ton rooftop unit but do not have the programming capability for night setback, one programmable thermostat is located in second floor corridor for ten ton rooftop unit, one programmable thermostat is located in first floor office suite for three ton furnace and one abandoned thermostat is located in main floor electrical room. Gas meter is located on South West end of the Shipping area near door. (Refer to Photo 7 in Appendix "B").

2.1.4 Controls: There is no DDC system in a building. Five thermostats were found in entire building to provide temperature control, two are located at third floor office suites one for each five ton rooftop unit but do not have the programming capability for night setback, one programmable thermostat is located in second floor corridor for ten ton rooftop unit, one programmable thermostat is located in first floor office suite for three ton furnace and one abandoned thermostat is located in main floor electrical room. No humidity control was found in the building.

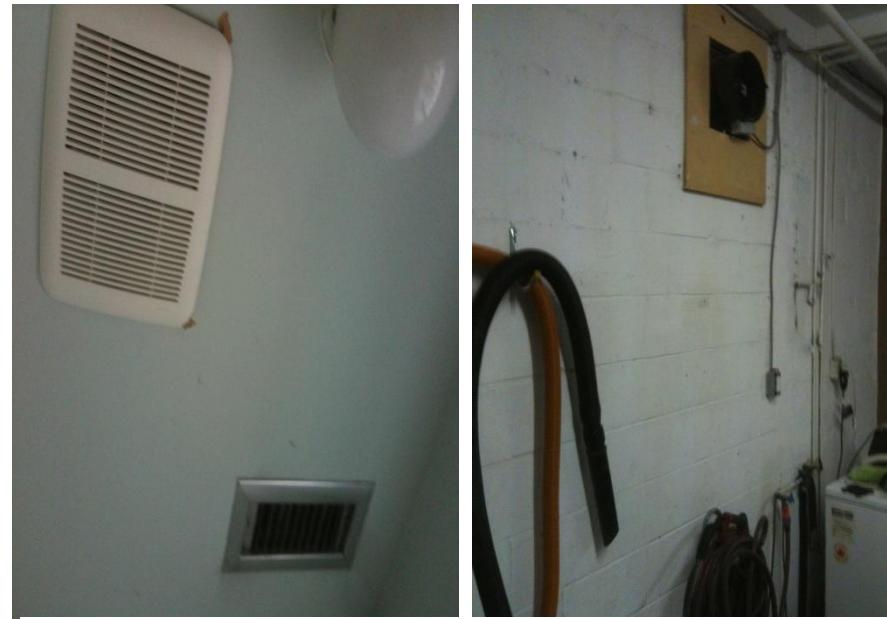
**Photo #8: First Floor Washroom & Shipping Area Fans.**

Building ventilation is achieved with operable windows. Three Rooftop units and one furnace have no fresh air system or simply missing economiser and fresh air kit. The washrooms at second and third floors are ventilated by operable windows. First floor washroom is provided with exhaust fan. All washrooms are provided with supply air grilles. Shipping area ventilation is achieved with one wall exhaust fan located in North wall. No humidity control was found in the building. (Refer to Photo 8 in Appendix "B").

2.1.2 Ventilation: Building ventilation is achieved with operable windows to provide natural ventilation. Three Rooftop units and one furnace have no fresh air system or simply missing economiser and fresh air kit. The washrooms at second and third floors are ventilated by operable windows. First floor washroom is provided with exhaust fan. All washrooms are provided with supply air grilles. Shipping area ventilation is achieved with one wall exhaust fan located on North wall.

- b) For 1st, 2nd and 3rd floor washrooms we recommend to provide a 75% effectiveness horizontal heat recovery ventilator to recover energy from exhaust stream. This unit will supply and exhaust the design air capacities as recommend by Ontario Building Code and shall be connected to occupancy sensor.

- c) For shipping area we are recommending to delete the wall mounted exhaust fan and replace it with 75% effectiveness horizontal heat recovery ventilator to recover energy from exhaust stream, which unable via switch to supply and exhaust the design air capacities as recommend by Ontario Building Code. Blank of the portion of the wall opening to match existing construction and provide R-20 insulation to minimize energy gain or loss.

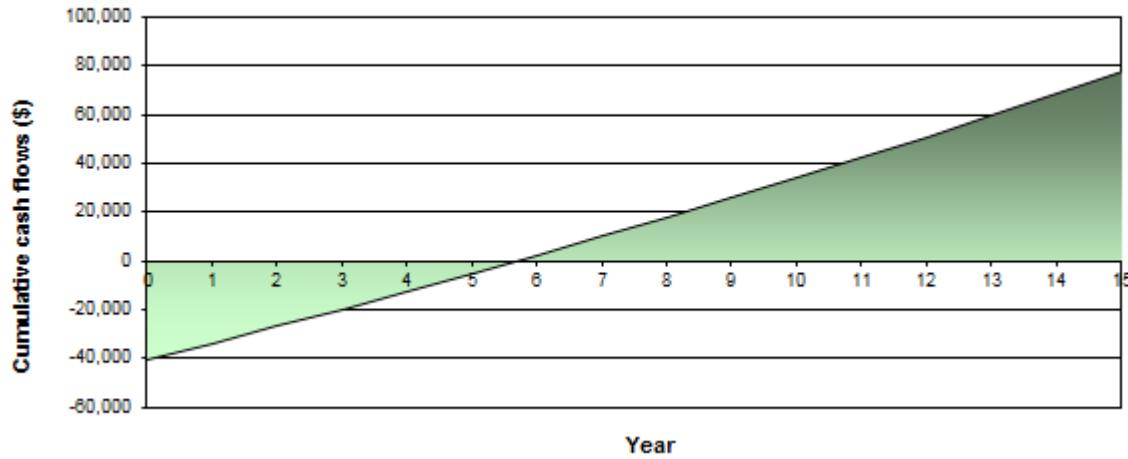
Cumulative cash flows graph

Incremental Cost Payback is 6 years (Excluding Education & Engineering Fees).
